LONGEVITY OF THE SEMCO TRUE 3Å WHEEL: CONFIRMED IN CONTINUOUS LABORATORY EXHAUST ENVIRONMENT

SITE INSPECTION SUMMARY:

SEMCO WHEELS SERVING THE DAVID H. KOCH CANCER RESEARCH BUILDING, JOHNS HOPKINS

DATE: September 7th, 2016

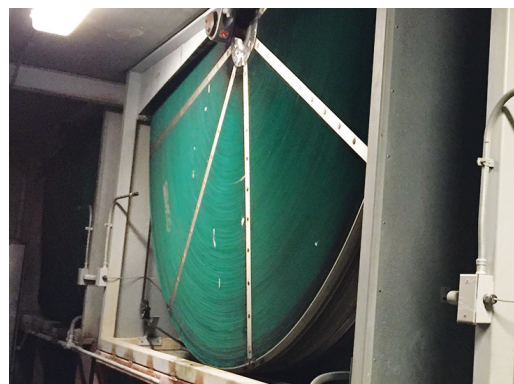
All of the wheel media sections were found to be tight with no gaps between sections, at the spokes or at the rims. All spoke systems looked good with no apparent loose bolts or obvious wear of any kind. In short, the fit and structural integrity of the media looked as it did when it was originally installed 16 years previously (see top photo on right).

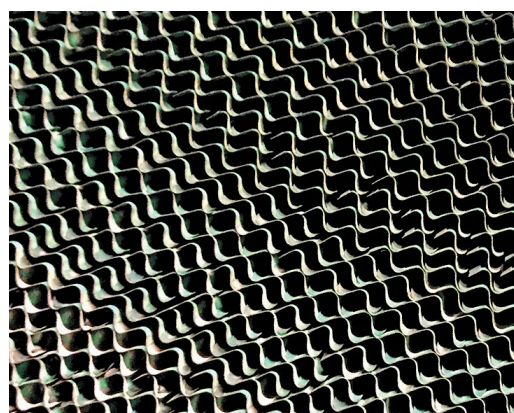
The wheel media was found to be very open with no plugging of any kind. It was quite easy to see through the transfer media. The pressure readings across the wheel taken at the Health and Safety monitor confirmed that the wheel pressure loss values were in agreement with the published data for the airflows reported for the system (see middle photo on right).

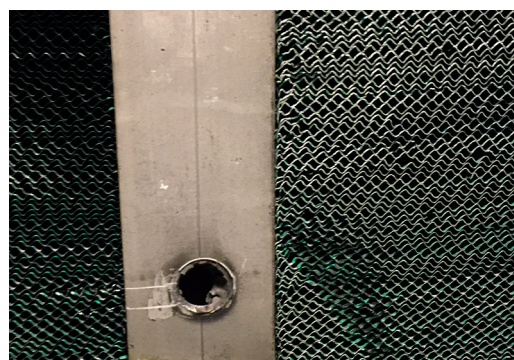
Two wheels (1-3 and 2-1) had media scarred near the outer rim. This appears to have occurred when the purge angles on these two units were found to have closed off at some point due to missing screws and rubbed the rotating transfer media. The media is still open and solid, so this is primarily a cosmetic issue at this point (see bottom photo on right).

were to allocate funds to begin replacing wheel media in the future as needed, the average life of wheels would be approximately 25 years. In this way, any retrofits could be easily accomplished with minimal down time and with plenty of advanced planning. The logical place to start would be the two wheels with scarred media at CRB I.
