LONGEVITY OF THE SEMCO TRUE 3Å WHEEL: CONFIRMED IN CONTINUOUS LABORATORY EXHAUST ENVIRONMENT

SITE INSPECTION SUMMARY:

FLÄKTGROUP® SEMCO® WHEELS SERVING THE DAVID H. KOCH CANCER RESEARCH BUILDING, JOHNS HOPKINS

DATE: September 7th, 2016

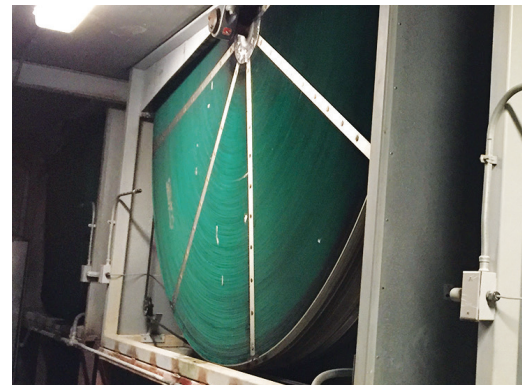
All of the wheel media sections were found to be tight with no gaps between sections, at the spokes or at the rims. All spoke systems looked good with no apparent loose bolts or obvious wear of any kind. In short, the fit and structural integrity of the media looked as it did when it was originally installed 16 years previously (see top photo on right).

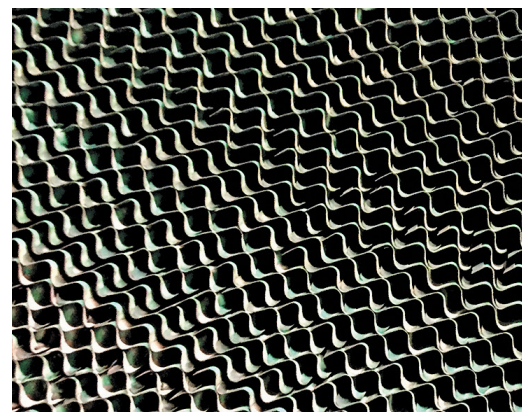
The wheel media was found to be very open with no plugging of any kind. It was quite easy to see through the transfer media. The pressure readings across the wheel taken at the Health and Safety monitor confirmed that the wheel pressure loss values were in agreement with the published data for the airflows reported for the system (see middle photo on right).

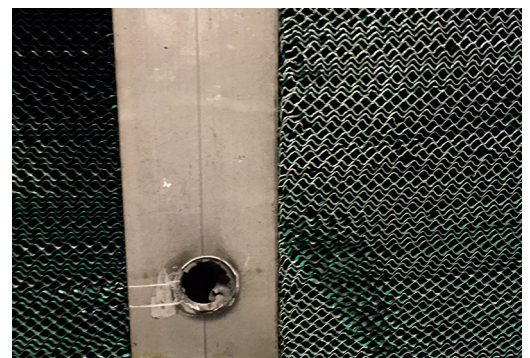
Two wheels (1-3 and 2-1) had media scarred near the outer rim. This appears to have occurred when the purge angles on these two units were found to have closed off at some point due to missing screws and rubbed the rotating transfer media. The media is still open and solid, so this is primarily a cosmetic issue at this point (see bottom photo on right).

were to allocate funds to begin replacing wheel media in the future as needed, the average life of wheels would be approximately 25 years. In this way, any retrofits could be easily accomplished with minimal down time and with plenty of advanced planning. The logical place to start would be the two wheels with scarred media at CRB I.
