LONGEVITY OF THE SEMCO TRUE 3Å WHEEL: CONFIRMED IN CONTINUOUS LABORATORY EXHAUST ENVIRONMENT

SITE INSPECTION SUMMARY:

FLÄKTGROUP® SEMCO® WHEELS SERVING THE DAVID H. KOCH CANCER RESEARCH BUILDING, JOHNS HOPKINS

DATE: September 7th, 2016

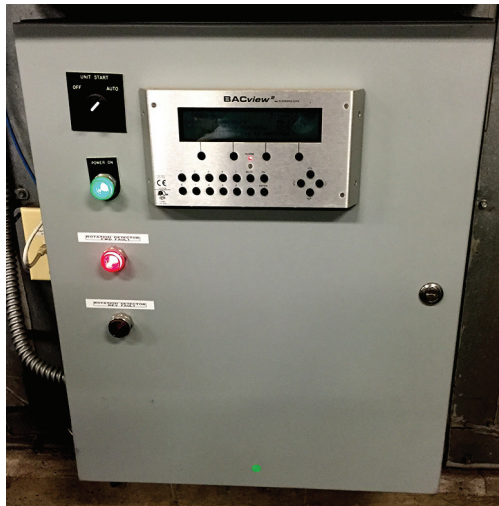
To assess the operational efficiency, especially latent performance which provides confirmation that the desiccant surface is still in place and active, performance was observed for system 4. Around 11:00 AM the outdoor air was 83.1 degrees and 56% relative humidity. The return space conditions were 73.3 degrees at 50% relative humidity and the supply air from the three wheels was 74.8 degrees and 52.8% relative humidity. The supply airflow was 60,000 cfm and the exhaust flow as 78,000 cfm. These values confirm

a sensible and latent effectiveness of 86% which was found to be in excellent agreement with the published data for a new SEMCO True 3Å (TE) wheel.
